# Final QA/QC Report

2017 LIDAR QA/QC FOR COASTAL TEXAS  
STATEMENT OF WORK #580170040

TEXAS WATER DEVELOPMENT BOARD

April 4, 2018

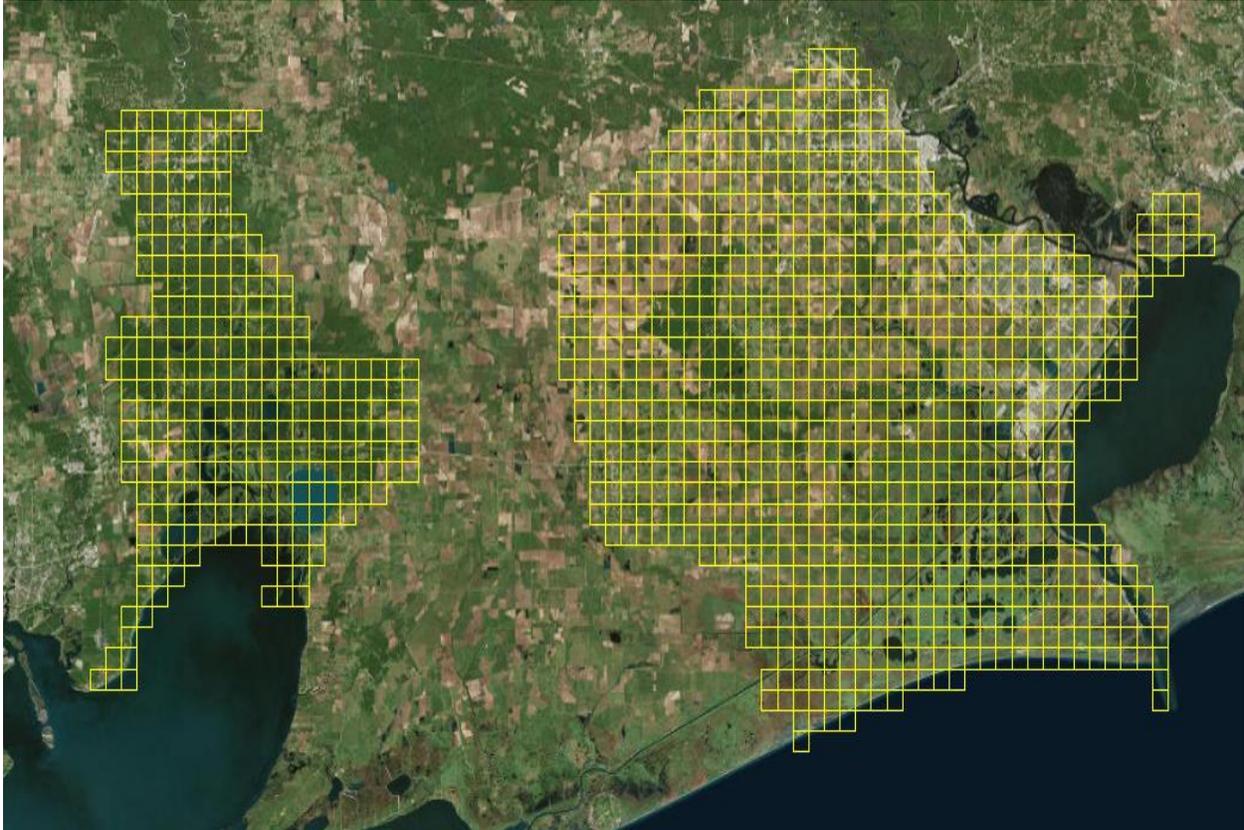
Figure 1 – TNRIS 2017 Coastal Texas Areas of Interest

Western AOI - 291.67 mi<sup>2</sup>  
Eastern AOI - 843.53 mi<sup>2</sup>

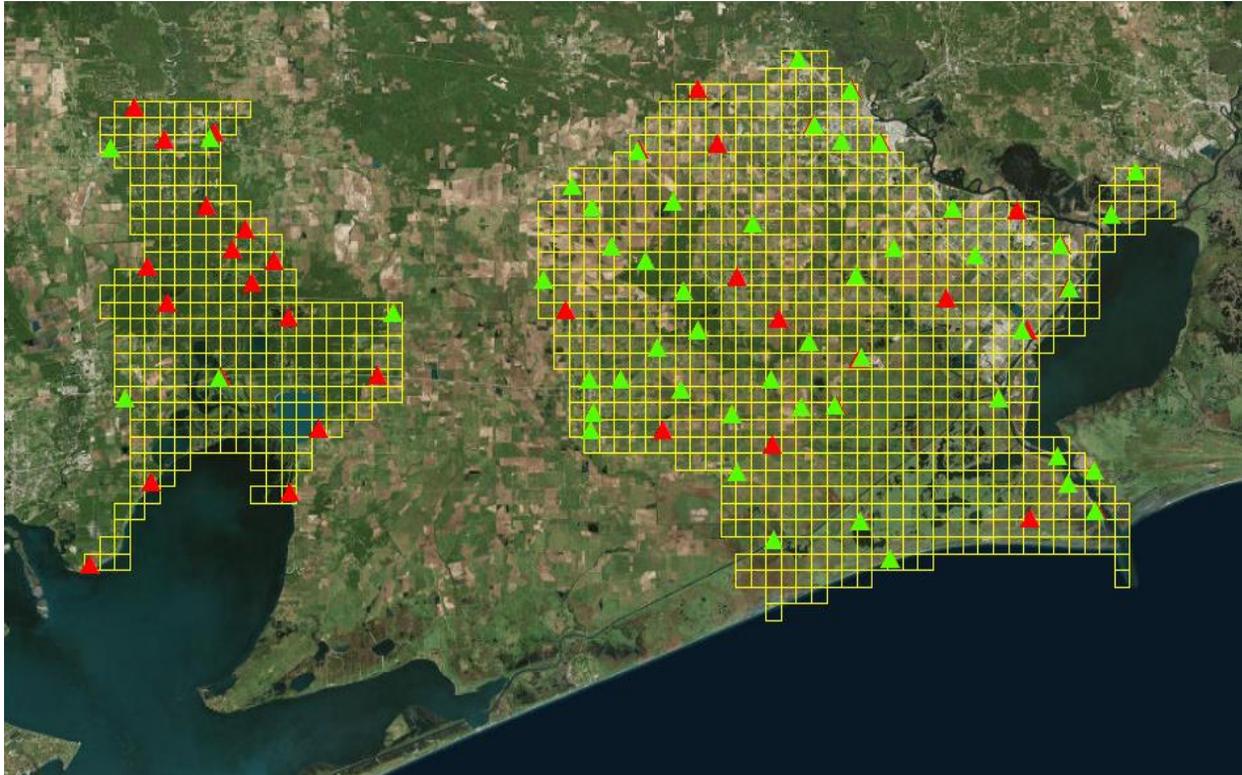
*Figure 2 – AECOM QA/QC Checkpoint Survey Plan*

The ground survey layout for the QA/QC checkpoints was developed by AECOM referencing USGS and ASPRS specifications with respect to distribution and vegetative cover. An accuracy requirement of 1.67 cm RMSE<sub>z</sub> (3.3 cm CE95) was required.

A total of 75 NVA and 30 VVA checkpoints were established across both AOIs.

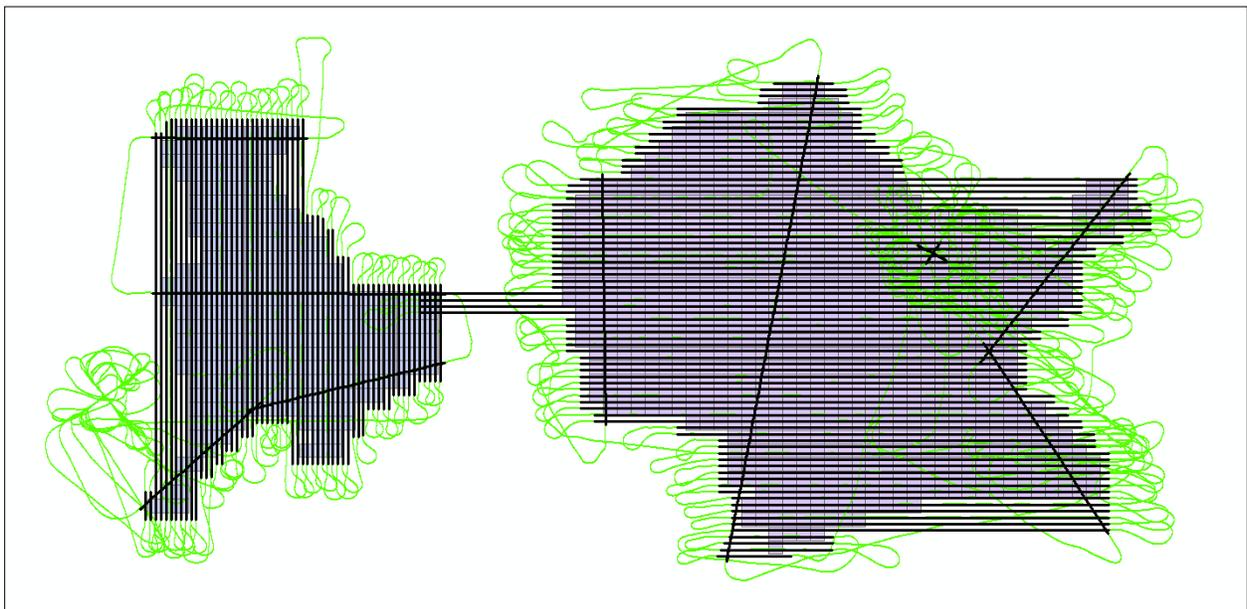
*Figure 3 – LiDAR Planned Flight lines (Black) overlaid As-Flown Trajectories (Green)*

The trajectory data captured from the aircraft's GPS, collected at 0.5 second intervals, were compared against the planned flight plans. A comparison of the planned flight lines and trajectories as they were flown are below. The as-flown data aligned well with the planned datasets.

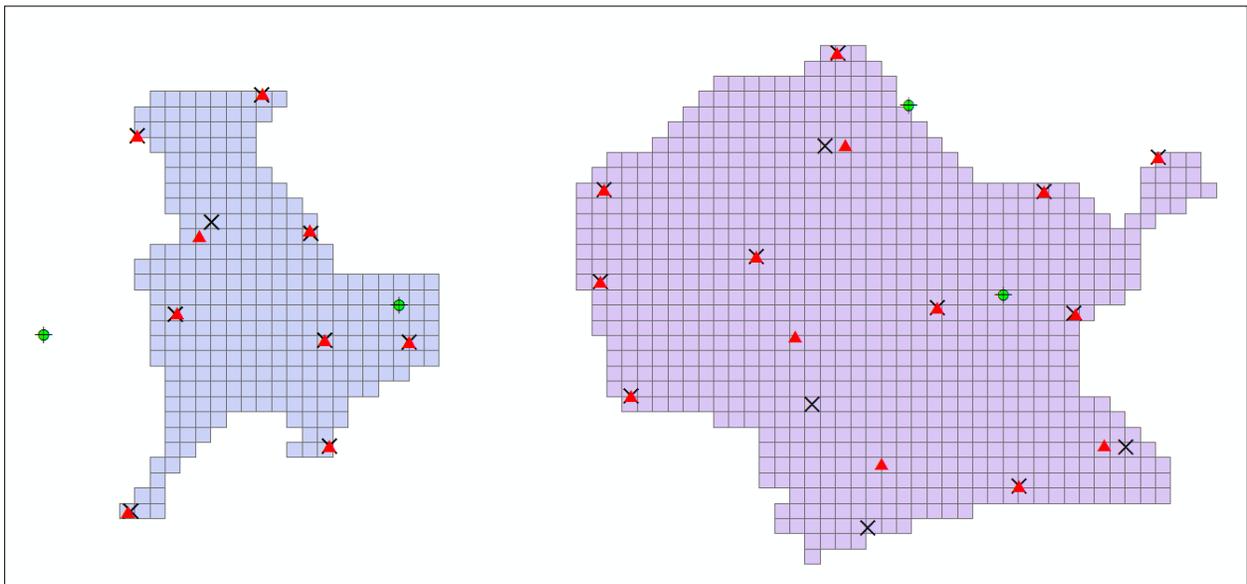
Figure 4 - Sanborn LiDAR Planned Control Locations (X) and Actual Control Locations (▲)

Survey points were evenly spaced, well dispersed, and for the most part closely mimic the planned control point locations, as can be seen in the graphic below. Two control points in the East AOI are shifted ~5 miles from their planned positions.

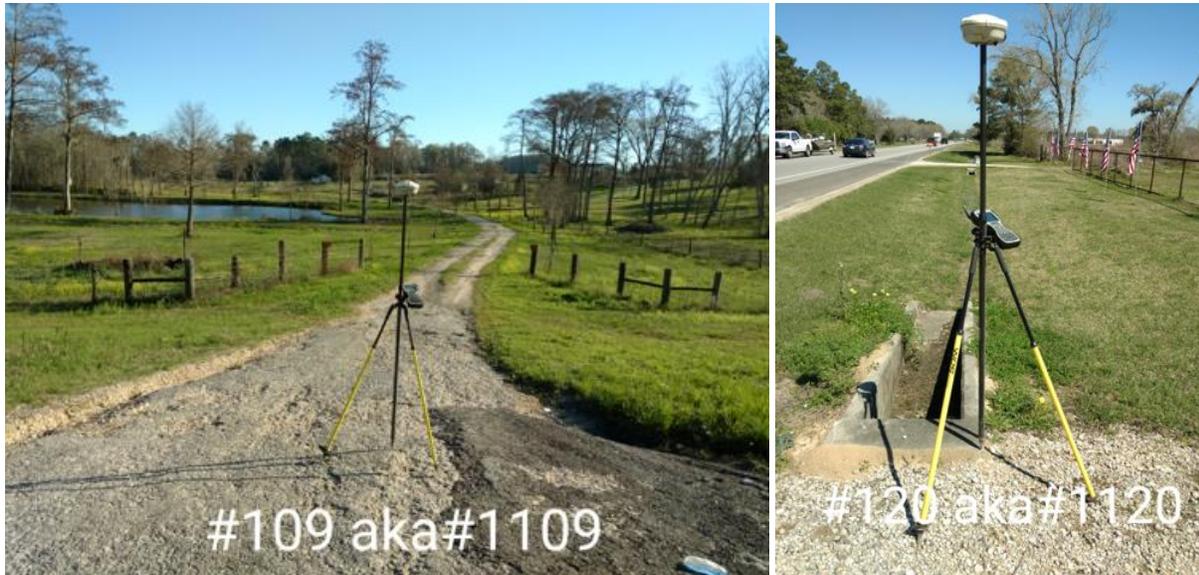
Figure 5 CP 1109 excused (left)  
Figure 6 CP 1120 excused (right)

- *Point 1120 proximity of surveyed point to culvert may impact vertical results*
- *Point 1109 appears to rest on a sloping and what may be an actively eroding surface which may impact vertical results*

Removal of points 1120 and 1109 resulted in an RMSEz of 8.252 cm using 18 checkpoints. This result is within the USGS QL1  $\geq 8$  PPSM absolute accuracy requirements.

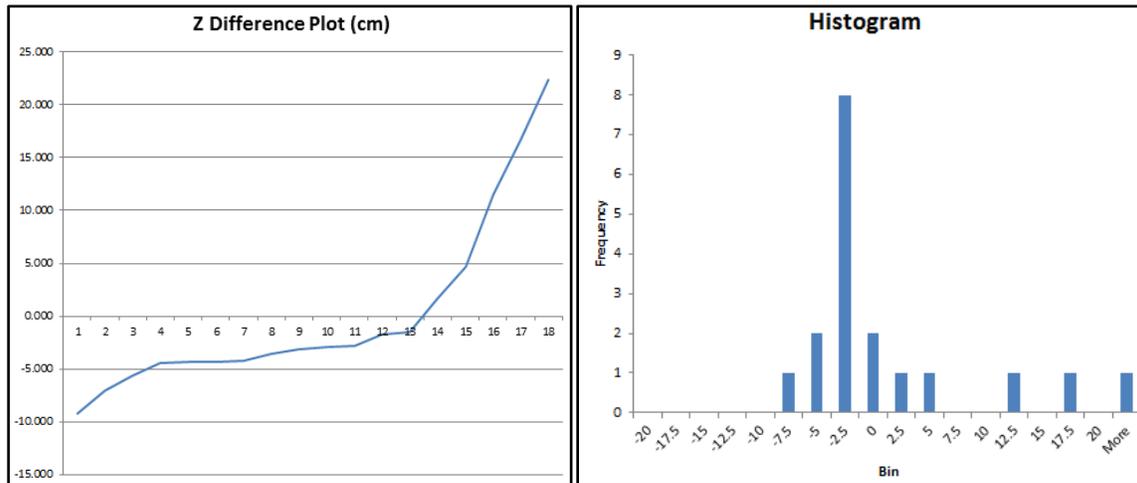
NVA Vertical Accuracy Statistics - NSSDA									
# of Pts	RMSEz (cm)	Std Dev (cm)	Mean (cm)	Median (cm)	Skew	Min (cm)	Max (cm)	95% CI (RMSE * 1.96) (cm)	95 <sup>TH</sup> Percentile (cm)
18	8.246	8.485	0.109	3.029	1.666	-9.200	22.370	16.163	17.619

NVA Accuracy Assessment Results	
<b>PASS</b>	Tested 16.16 cm vertical accuracy at 95% confidence level in bare earth using RMSEz x 1.9600.

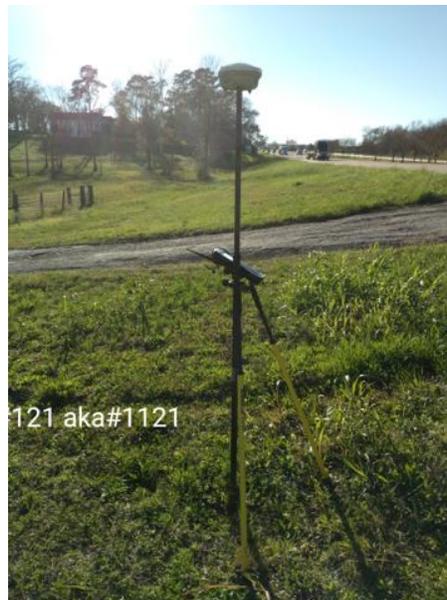
Figure 7 CP 1121 excused

- Point 1121 appears to rest on sloping terrain which may impact vertical results

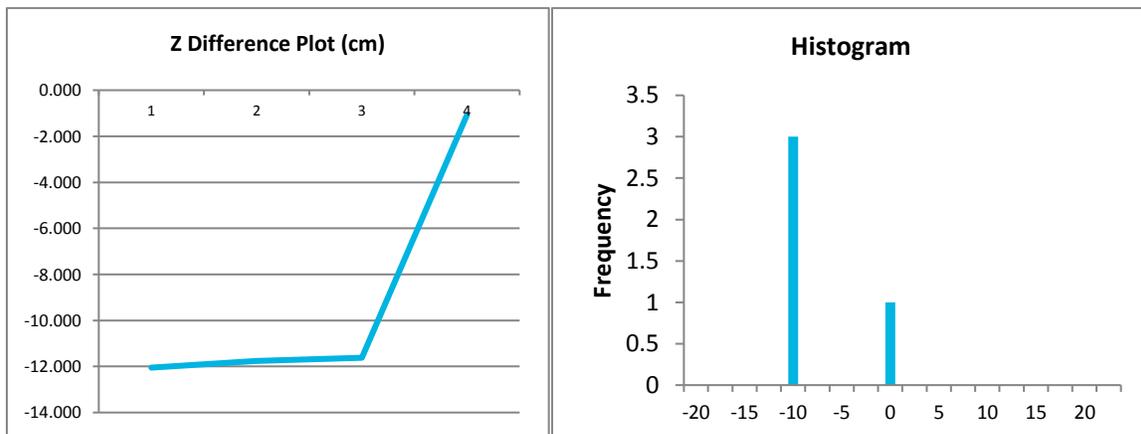
**VVA Vertical Accuracy Statistics - NSSDA**

# of Pts	RMSEz (cm)	Std Dev (cm)	Mean (cm)	Median (cm)	Skew	Min (cm)	Max (cm)	95% CI (RMSE * 1.96) (cm)	95 <sup>TH</sup> Percentile (cm)
4	10.256	5.366	-9.143	11.685	1.991	-12.100	-1.100	20.101	12.051

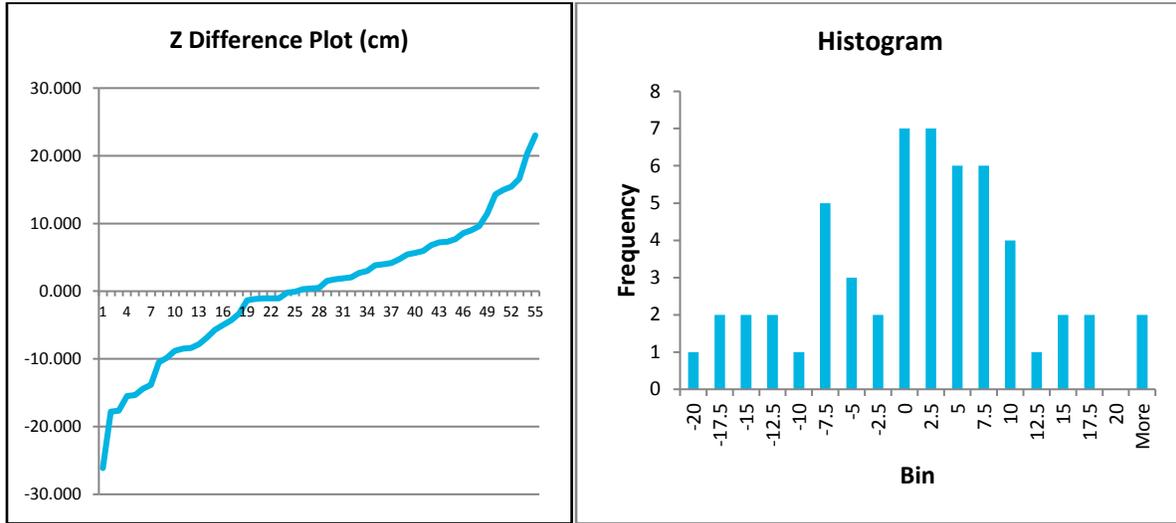
NVA Vertical Accuracy Statistics - NSSDA									
# of Pts	RMSEz (cm)	Std Dev (cm)	Mean (cm)	Median (cm)	Skew	Min (cm)	Max (cm)	95% CI (RMSE * 1.96) (cm)	95 <sup>TH</sup> Percentile (cm)
55	9.992	10.080	0.268	-0.513	-0.190	-26.129	23.022	19.584	18.568

NVA Accuracy Assessment Results	
<b>PASS</b>	Tested 19.584 cm vertical accuracy at 95% confidence level in bare earth using RMSEz x 1.9600.

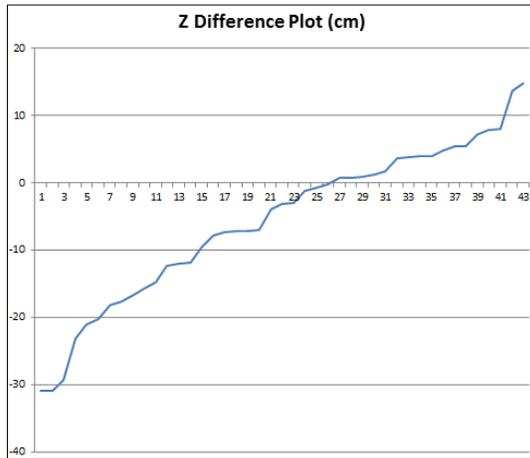
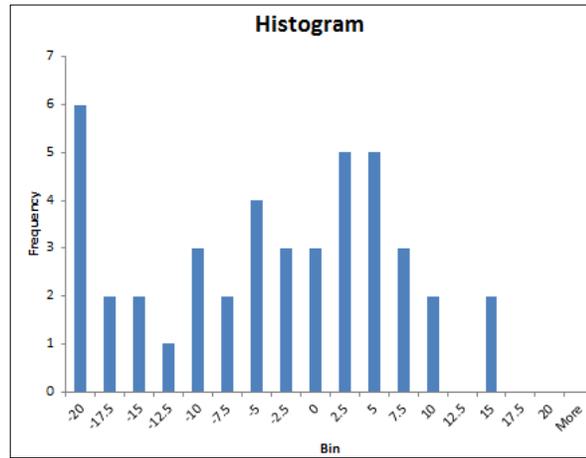
VVA Vertical Accuracy Statistics - NSSDA									
# of Pts	RMSEz (cm)	Std Dev (cm)	Mean (cm)	Median (cm)	Skew	Min (cm)	Max (cm)	95% CI (RMSE * 1.96) (cm)	95 <sup>TH</sup> Percentile (cm)
43	12.853	11.664	-5.684	3.157	-0.511	-30.983	14.839	25.192	28.648

VVA Accuracy Assessment Results	
<b>PASS</b>	Tested 28.648 cm vertical accuracy at 95 <sup>th</sup> percentile in vegetated areas.

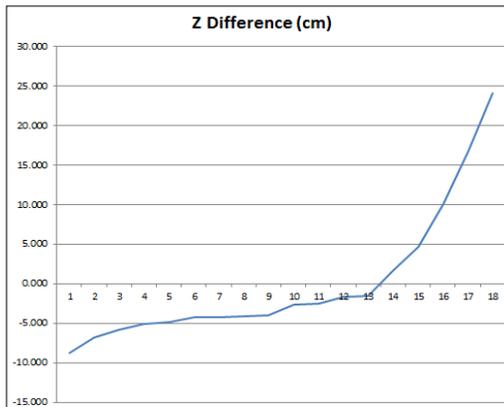
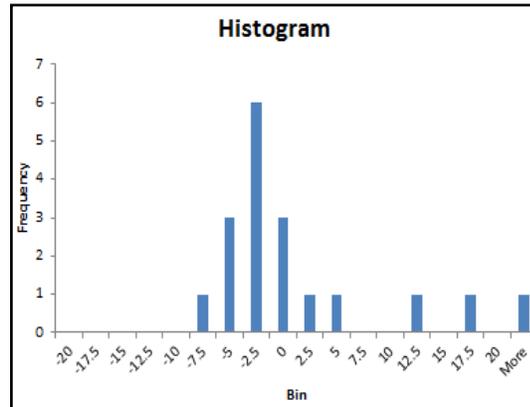
<b>NVA Vertical Accuracy Statistics - NSSDA</b>									
# of Pts	RMSEz (cm)	Std Dev (cm)	Mean (cm)	Median (cm)	Skew	Min (cm)	Max (cm)	95% CI (RMSE * 1.96) (cm)	95 <sup>TH</sup> Percentile (cm)
18	8.432	8.676	0.076	3.258	1.813	-8.709	24.172	16.526	17.817

<b>NVA Accuracy Assessment Results</b>	
<b>PASS</b>	Tested 16.53 cm vertical accuracy at 95% confidence level in bare earth using RMSEz x 1.9600

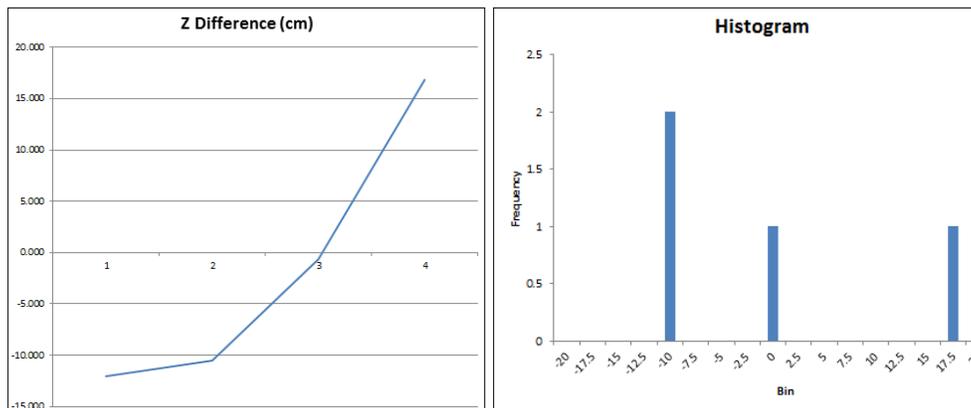
<b>VVA Vertical Accuracy Statistics - NSSDA</b>									
# of Pts	RMSEz (cm)	Std Dev (cm)	Mean (cm)	Median (cm)	Skew	Min (cm)	Max (cm)	95% CI (RMSE * 1.96) (cm)	95 <sup>TH</sup> Percentile (cm)
4	11.602	13.272	-1.581	5.552	1.248	-12.038	16.818	22.740	16.101

<b>VVA Accuracy Assessment Results</b>	
<b>PASS</b>	Tested 16.10 cm vertical accuracy at 95 <sup>th</sup> percentile in vegetated areas

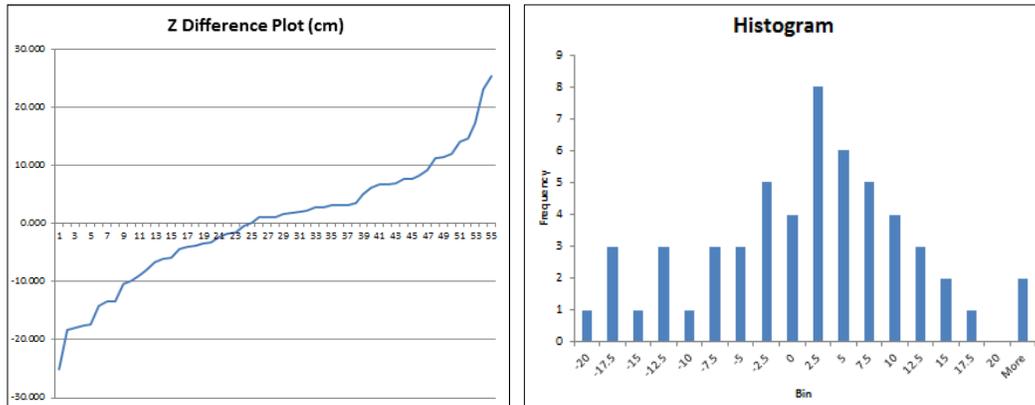
NVA Vertical Accuracy Statistics - NSSDA									
# of Pts	RMSEz (cm)	Std Dev (cm)	Mean (cm)	Median (cm)	Skew	Min (cm)	Max (cm)	95% CI (RMSE * 1.96) (cm)	95 <sup>TH</sup> Percentile (cm)
55	10.297	10.392	0.081	-1.045	-0.066	-25.059	25.345	20.182	20.713

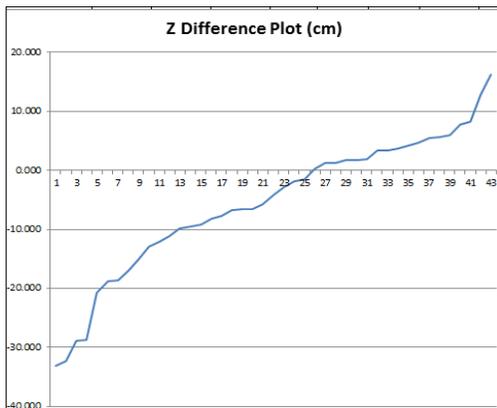
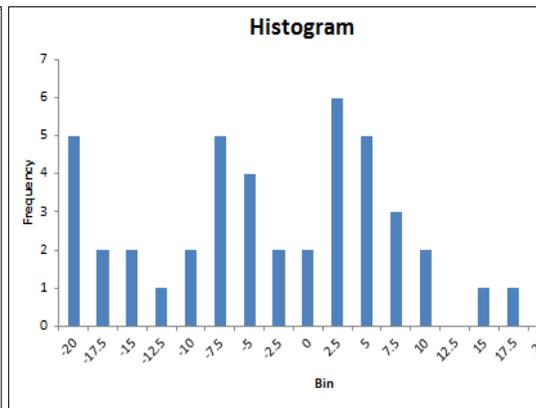
VVA Vertical Accuracy Statistics - NSSDA									
# of Pts	RMSEz (cm)	Std Dev (cm)	Mean (cm)	Median (cm)	Skew	Min (cm)	Max (cm)	95% CI (RMSE * 1.96) (cm)	95 <sup>TH</sup> Percentile (cm)
43	12.965	11.837	-5.589	4.186	-0.662	-33.121	16.302	25.412	28.903

VVA Accuracy Assessment Results	
<b>PASS</b>	Tested 28.90 cm vertical accuracy at 95 <sup>th</sup> percentile in vegetated areas
